Learn from the mistakes of others; you'll not live long enough to make them all yourself . . . **Issue 1/2004**

Sometimes You Do, Sometimes You Don't...

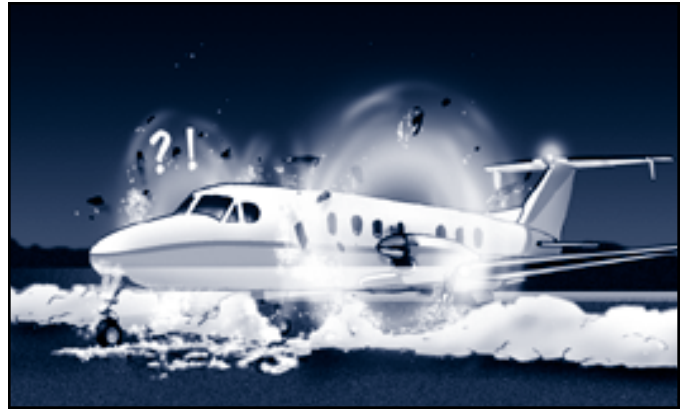
Artist's impression of collision with windrow.

On January 11, 2003, a Beech 1900D was taxiing on Runway 02/20 at St. John's International Airport, Nfld., when the aircraft struck a 2-ft high windrow, which lay across the runway just to the north of Taxiway Charlie. There were no injuries to the 10 passengers and 2 crew members. The aircraft sustained substantial damage. This synopsis is based on the Transportation Safety Board of Canada (TSB) Final Report A03A0002.

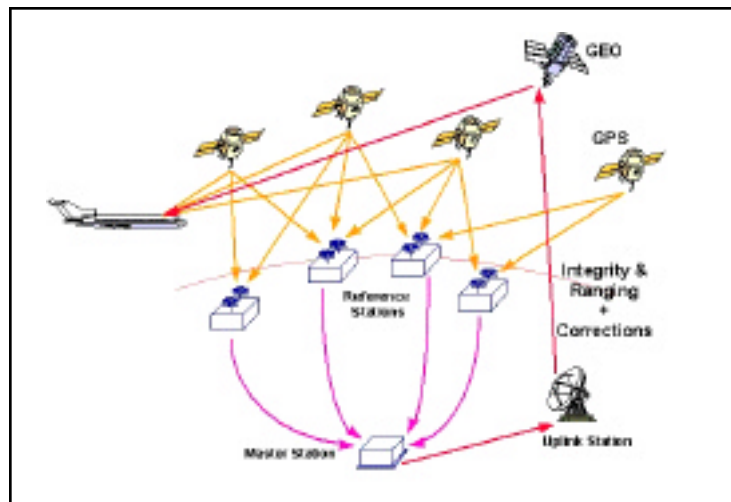
The above diagram illustrates WAAS system elements and data flow.

Aircraft WAAS receivers apply the WAAS message to the data from GPS satellites, resulting in horizontal and vertical accuracy that is usually better than 2 m. Even more importantly, the integrity portion of the message provides assurance that the aircraft will not be misled by a faulty satellite signal. The end result is a high availability of en route, terminal and approach guidance.

Like GPS, WAAS supports non-precision approaches, but it also supports approaches with vertical guidance to decision altitudes as low as 250 ft above ground. This new level of service is termed "LPV" by the FAA because the lateral guidance is as accurate as an instrument landing system (ILS)-based precision approach, and because it provides vertical guidance (Lateral Precision, Vertical guidance). LPV approaches will mean lower decision altitudes, therefore higher airport usability at many sites. Accident records and safety analysis, based on many years of experience with ILS, show that approaches with vertical guidance have a significantly better safety record than non-precision approaches. Why? Vertical guidance translates into a stabilized descent to a decision altitude. The decision to land or start a missed approach is therefore made at a specific point. There have been numerous
